Preventing Infection in MRI

-Best Practices: Infection Control in and around MRI Suites-

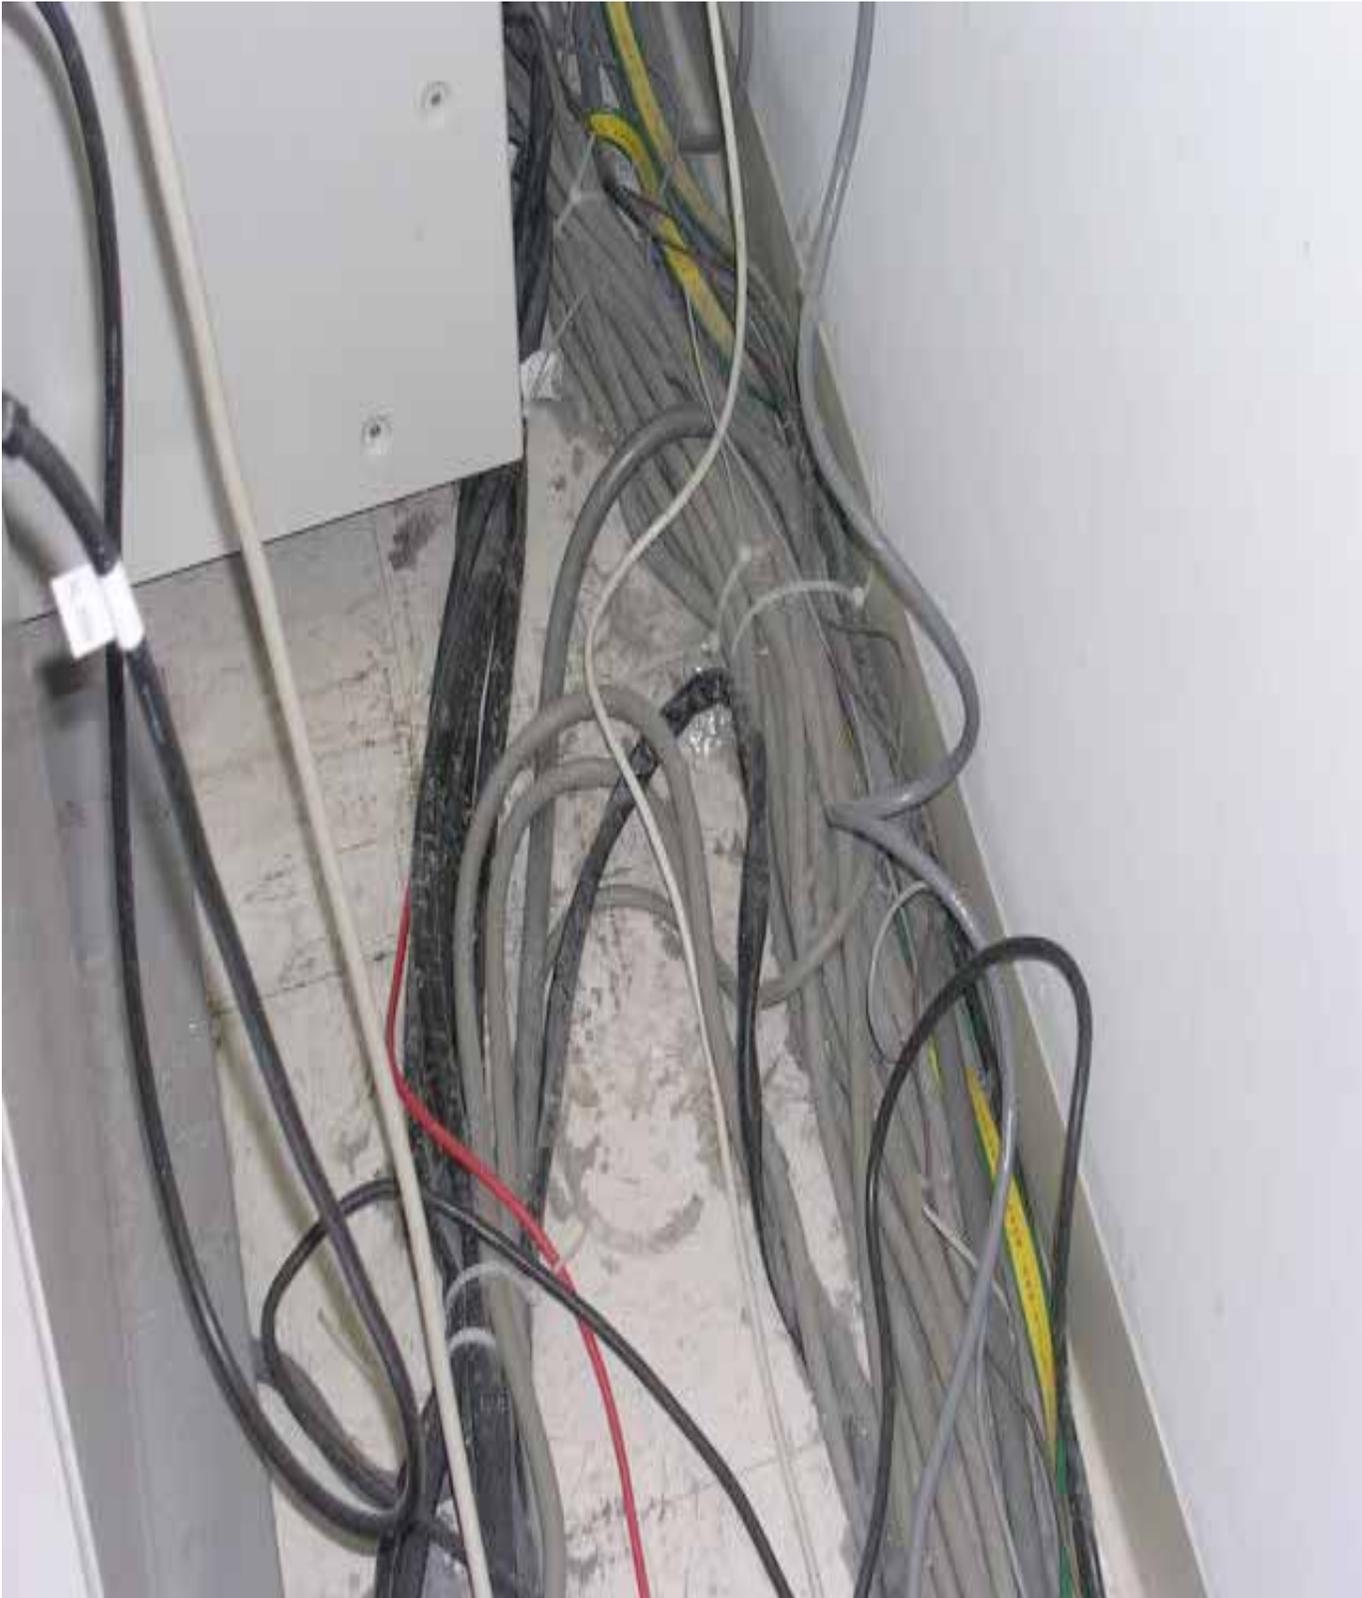
Cables in the MRI Room

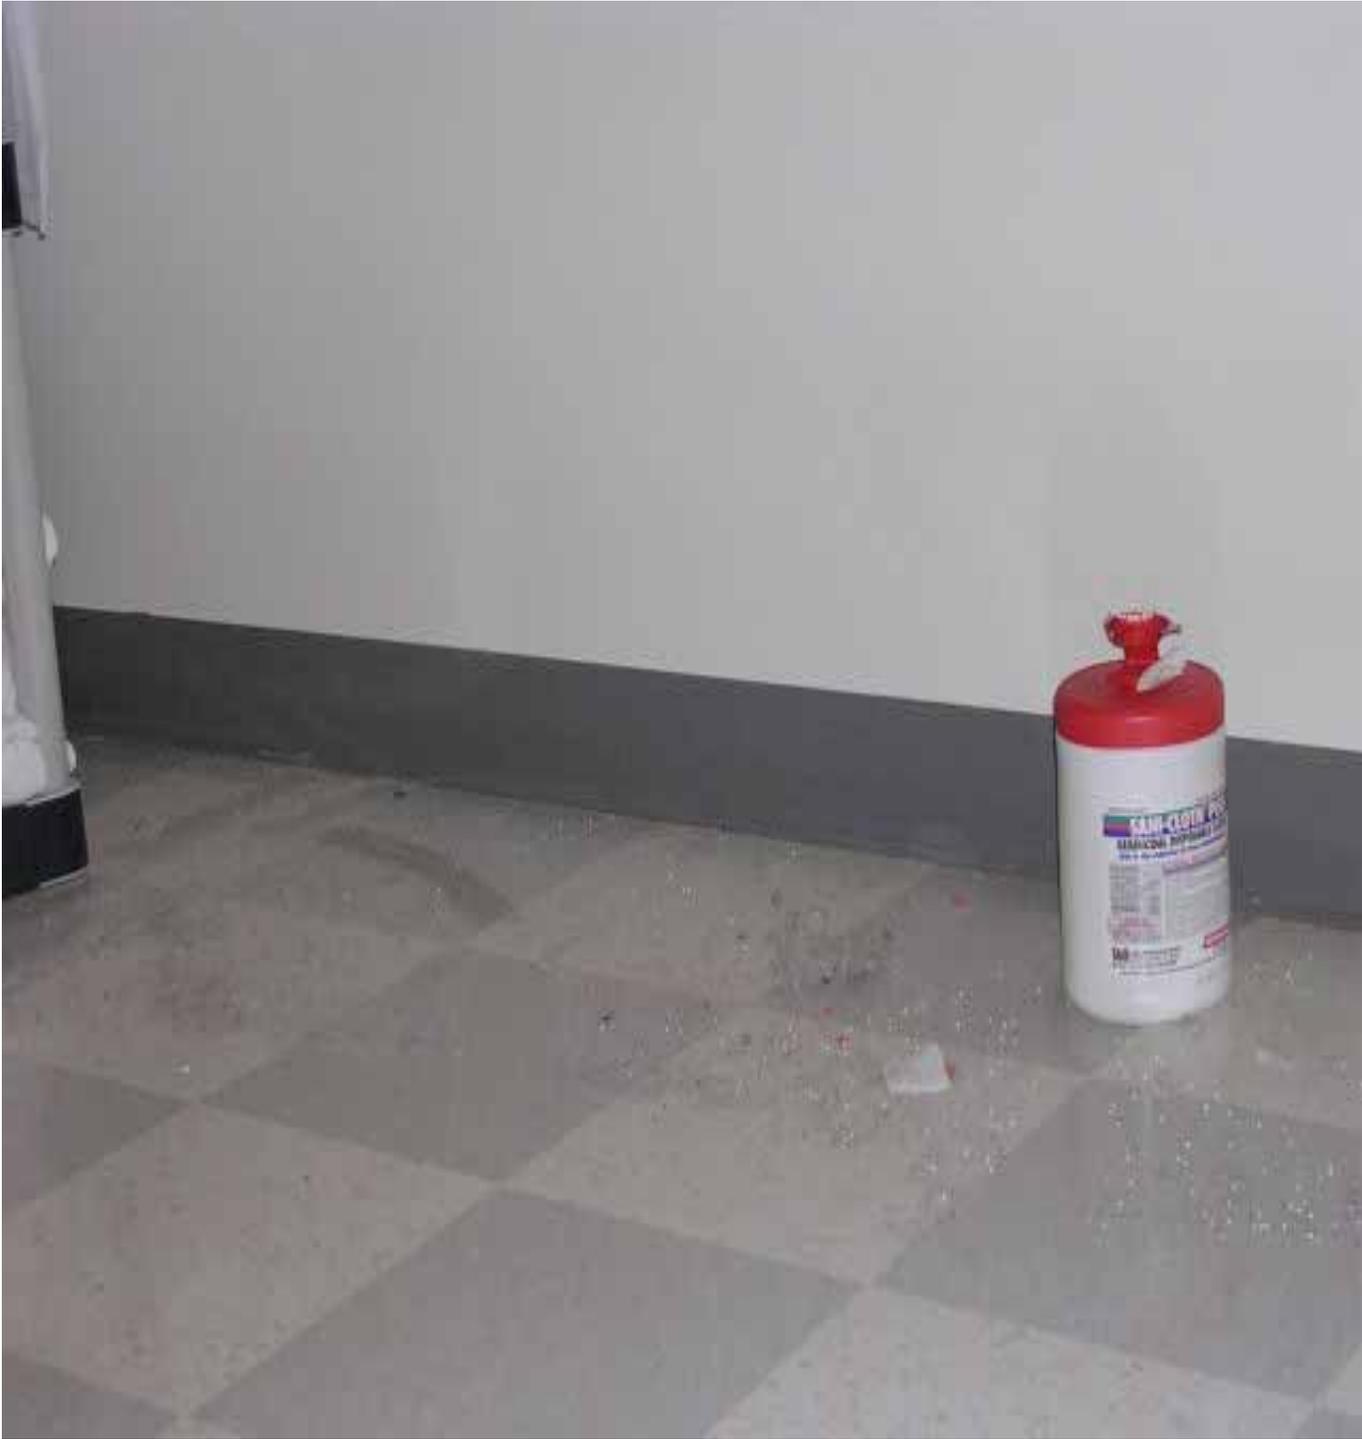
MRI Floor – Note that only the front half has been cleaned

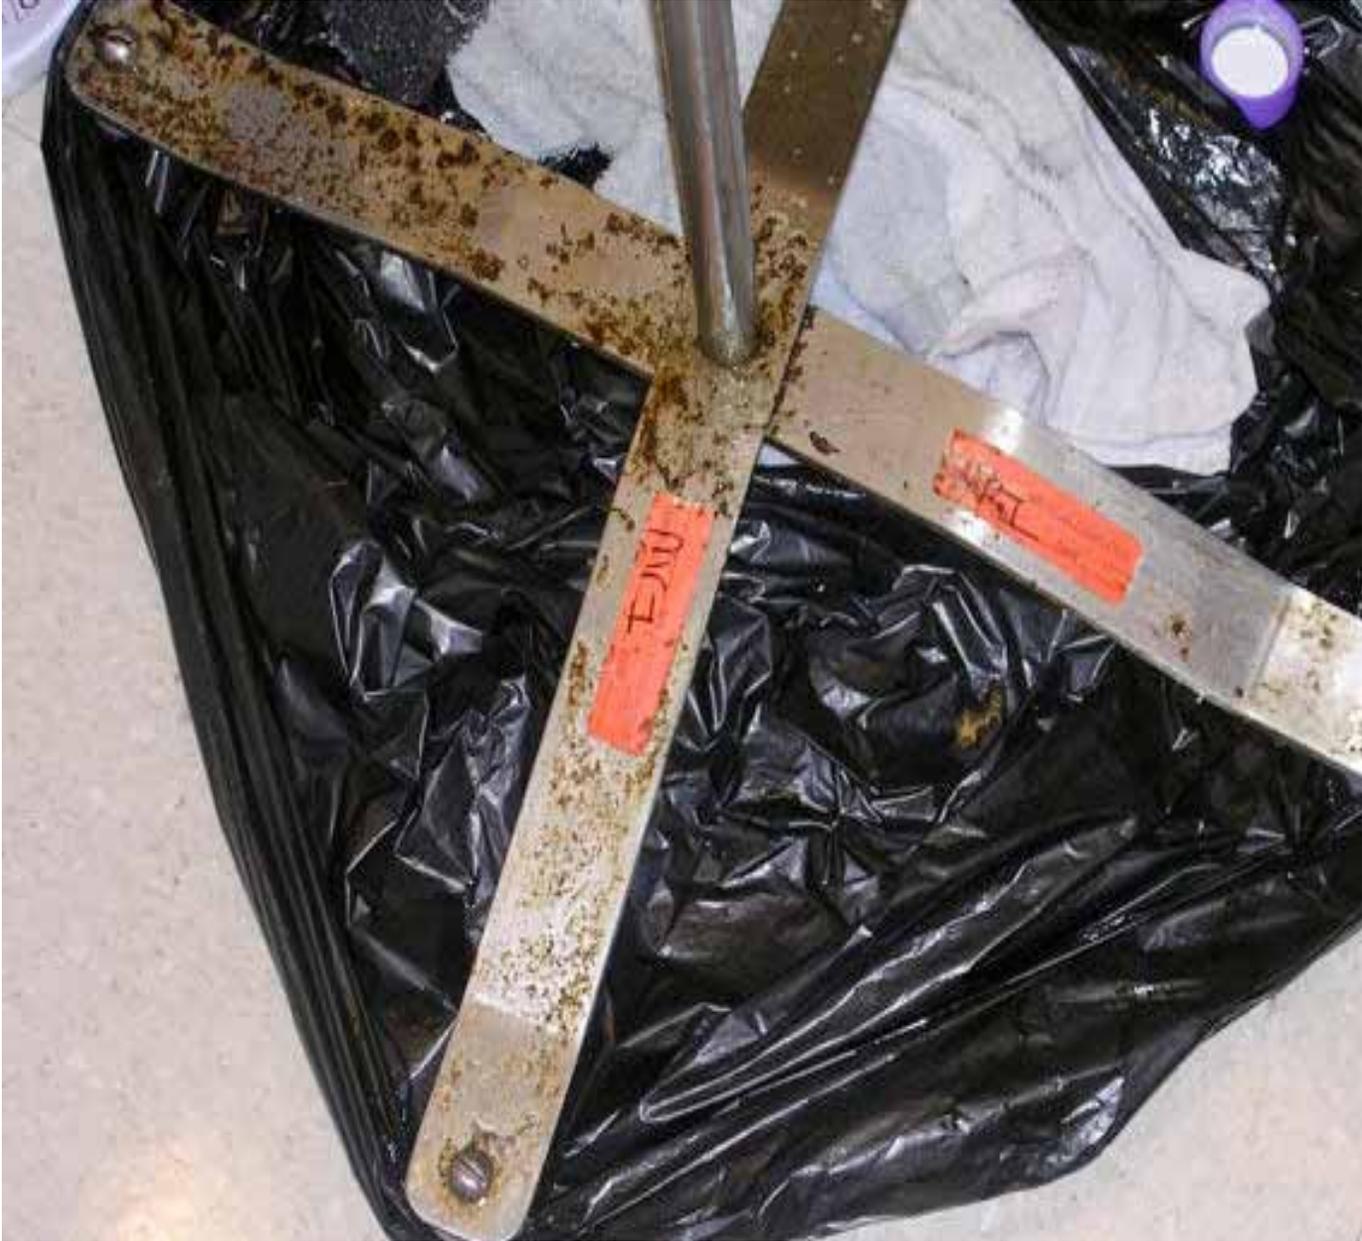
MRI-Compatible Aluminum IV Pole

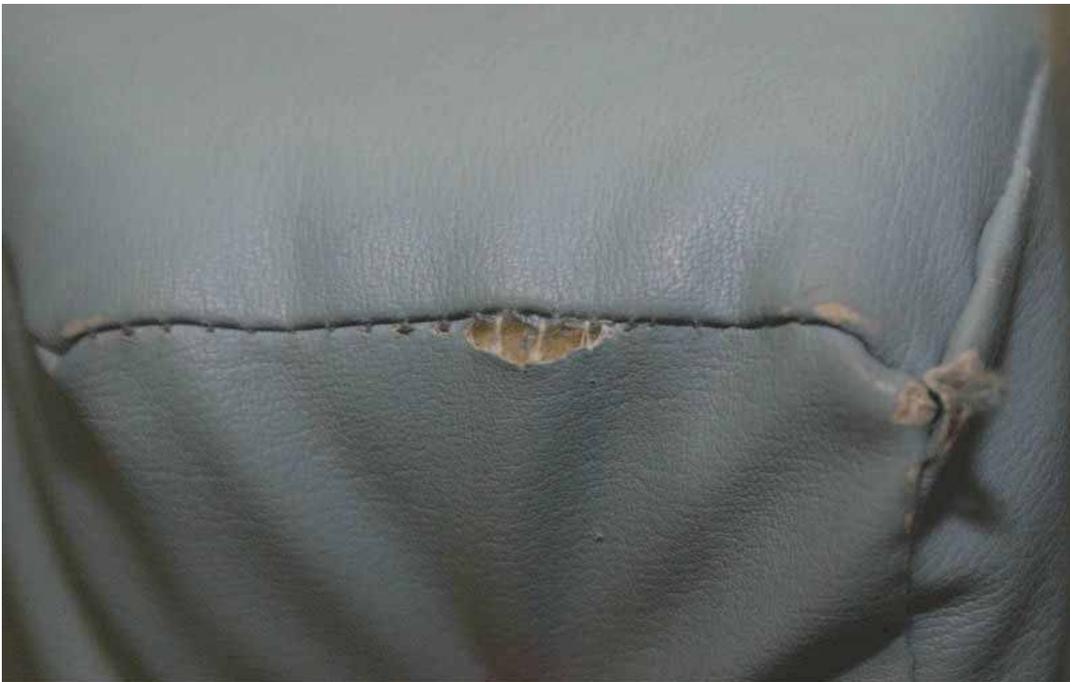
In the late 1980's and early 1990's when many of the pads systems in use today were developed, they were not designed to take the wear-and-tear of five to ten thousand patients a year for so many years. The fabric covers were coated with some type of plastic to make it water proof. However this plastic wears off especially with cleaning solutions as well as with use. As a result, pad coverings have worn out exposing the foam core or have lost their ability to prevent penetration of bacteria and fluids into the central core, where it is not possible to be cleaned.

Torn and Frayed Table Pad

Table pads inherently have air within them. When a patient lies down on the pads, this air is forced out through any hole or seam in the covering materials. This can cause the bacteria contaminating the central foam core to become ejected from the pad and aerosolize into the room environment. Of course the reverse air flow caused by the patient arising off the pads causes infectious materials to be drawn into the foam core from the surface, which is then re-ejected into the air when the next patient lies on the pad. There have been numerous articles discussing the possibility of MRSA or other pathogenic microorganisms becoming airborne during activities such as bed making⁴³ and thus the possibility that MRSA can be transmitted among patients through the air (Shiomori.)⁴⁴. There is also a suggestion that airborne MRSA may play a role in MRSA colonization of the nasal cavity or respiratory tract⁴⁵. Wilson showed that the presence of airborne MRSA in an area is strongly related to the presence and number of MRSA colonies and infected patients in that area⁴⁶. Shiomori states that measures should be taken to prevent the spread of airborne MRSA to control nosocomial MRSA infection⁴⁷.

This is clearly another reason why all pads must be inspected with a magnifying glass, and if any holes or loss of integrity of the covering material in any way is detected, the pads *must be replaced*.
